CIA/PIR-77044

CIA IMAGERY ANALYSIS DIVISION

BALTIC SHIPYARD 189

LENINGRAD, USSR

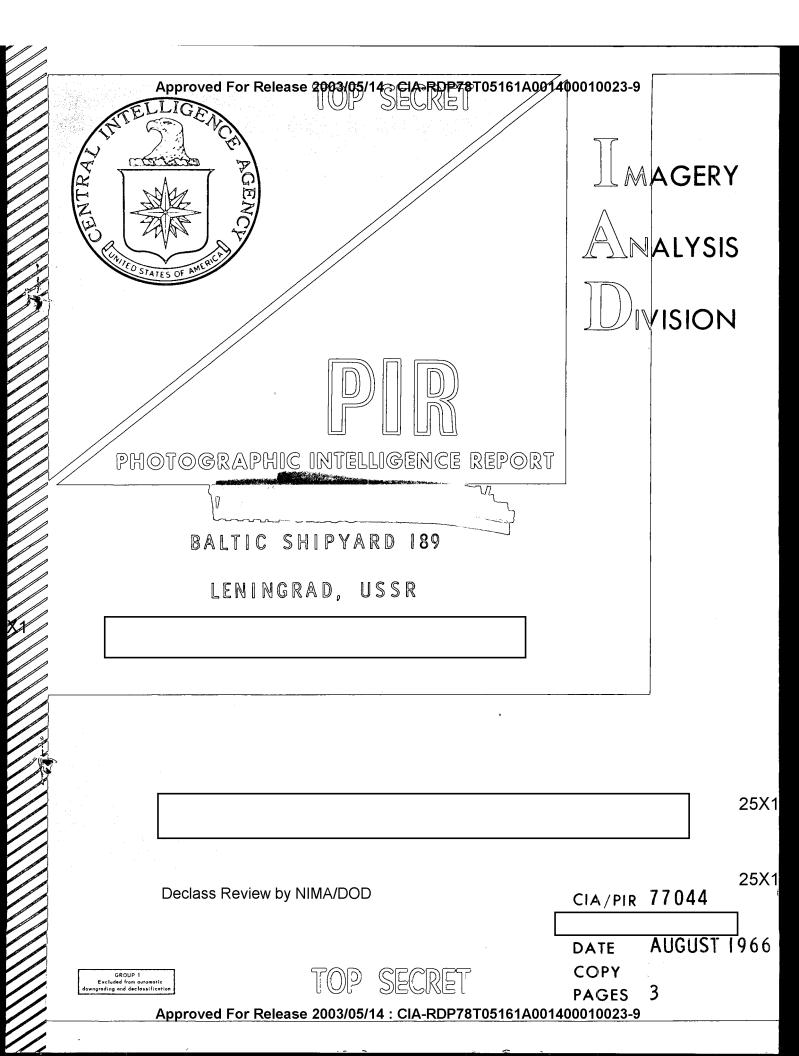
CIA IMAGERY ANALYSIS DIVISION
LO	CATION: BALTIC SHIPYARD 189 CATION: LENINGRAD, USSR O COORDS: 59-55N 030-16E
	KEY TO ANNOTATIONS
1.	SOFIYA Class tanker alongside fitting-out quay (LOA approx 750'). See annotation 1,

2.	SOFIYA Class tanker alongside fitting-out quay (LOA approx 750'). See annotation 2,
3.	Possible YANTARNYY (modified KALININGRAD/SEVASTOPOL) Class Refrigerated Fish Transport alongside fitting-out quay (LOA approx 430'). A very large floating crane is positioned along the starboard bow of this ship. See annotation 3,

4.	Probable after portion of large hull under construction on building way (measurements undetermined). See annotation 4,
5.	Probable hull under construction on building way (apparent length approx 430'). See annotation 5,

6.	After portion of large vessel under construction on building way (measuments undetermined). See annotation 6,
7 .	Unidentified imagery alongside quay near launching basin (measurements undetermined). It cannot be determined whether the submarine seen at annotation 8, has yet been moved into the transporter dock seen at annotation 7, A submarine is later seen in a transporter dock in this position on (see ground photo inset, PIR).

3.	Two unidentified small craft inside launching basin (measurements undetermined).
